26 July 2004

**Evaluation of IStop™ Cribbing and Chewing Deterrent Product to Reduce Pileated
Woodpecker Damage to Utility Poles**

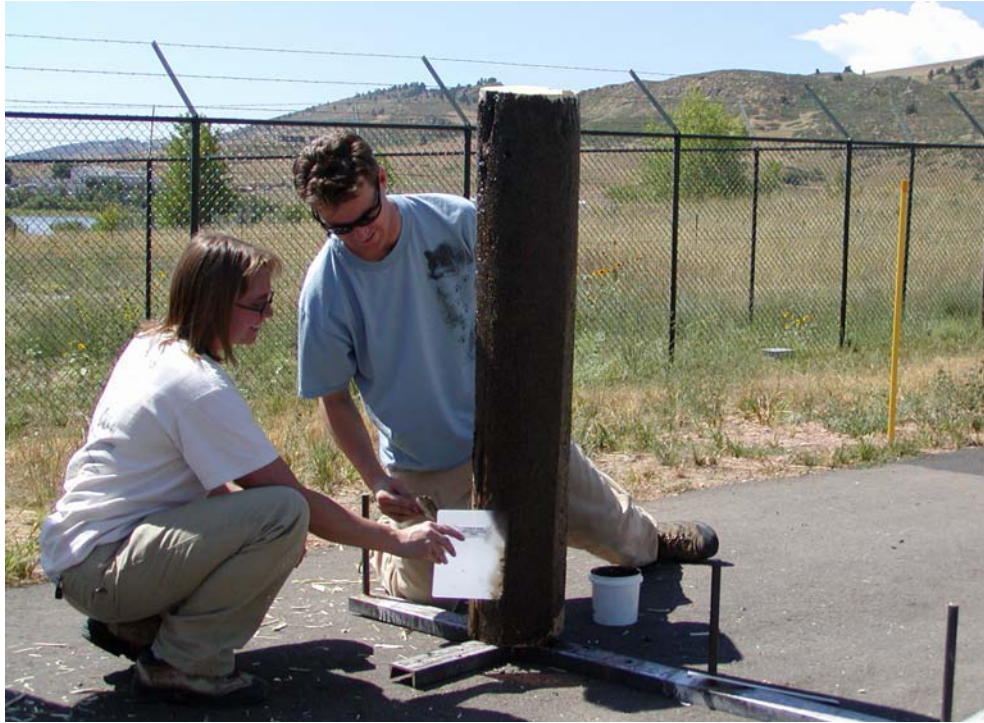
Figure 1: National Wildlife Research Center Staff apply the IStop-CC™ Sniff ‘N’ Stop deterrent (dark brown color), full treatment, to a utility pole section.

Full Treatment: The utility pole section was completely covered with a 0.30 cm to 0.63 cm layer of the deterrent material using a putty knife (Figure 1).

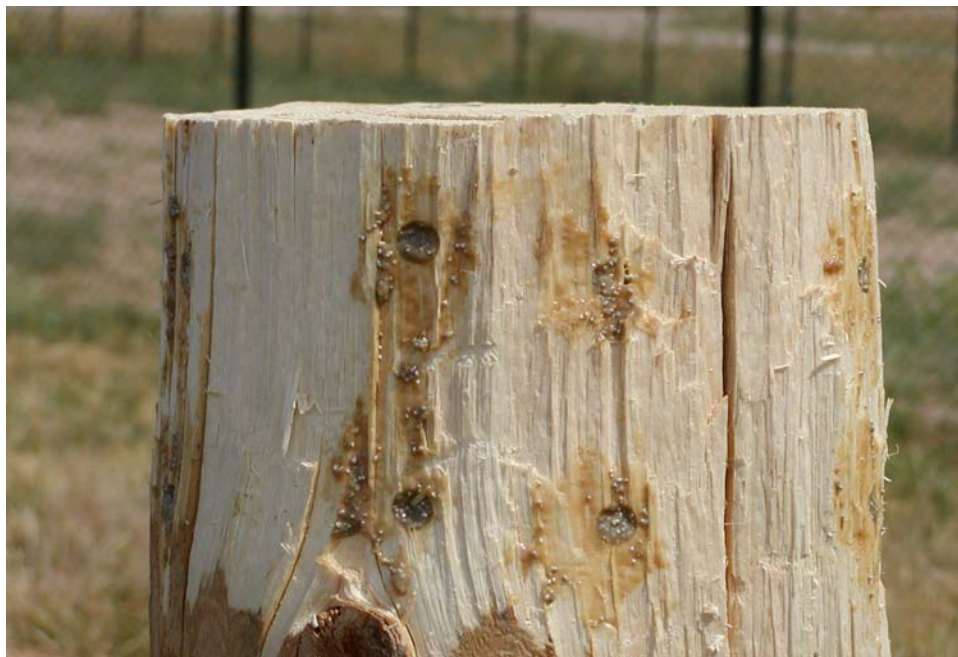
Figure 2: IStop-CC™ Sniff ‘N’ Stop deterrent, plug treatment. Each pole was perforated every 7.6 cm around the circumference of the pole section. Holes were filled with the product using a hand trowel.

Plug Treatment: The utility pole section was perforated with 1.27 cm diameter holes drilled 2.5 cm deep and spaced 7.6 cm apart. Each hole was filled with the deterrent using a trowel (Figure 2). The remaining surface area of the pole was left untreated.

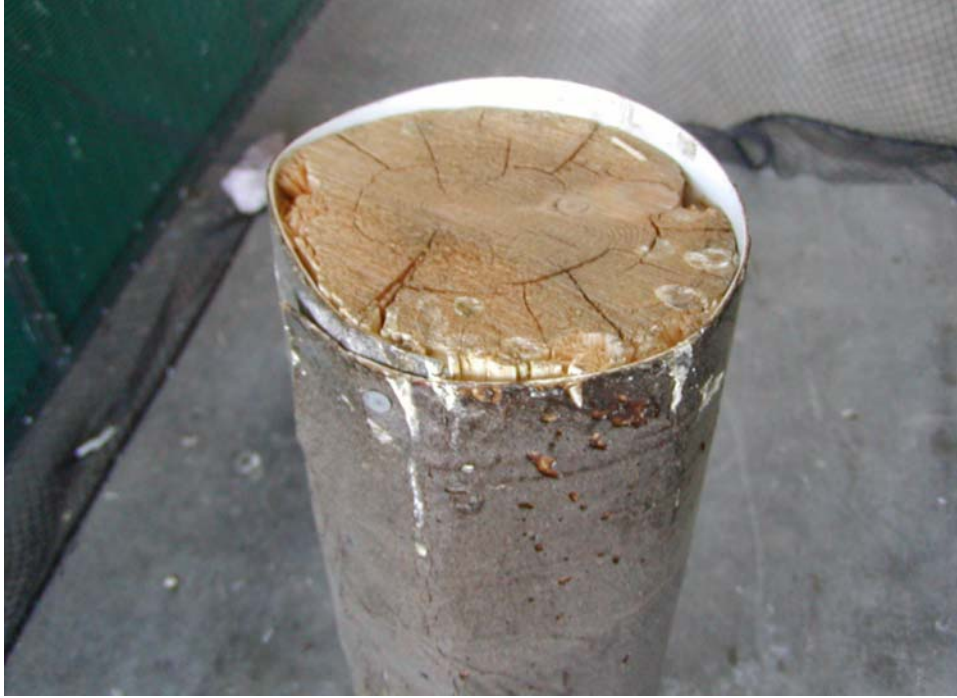
Figure 3: IStop-CC™ Epoxy Resin System, wrap treatment. A precured sheet of epoxy and PVC sheeting was nailed to the pole and cut to fit. Top of pole, as seen, was left exposed.

Wrap Treatment: A PVC sheet precurred with Sniff 'N' Stop deterrent was wrapped around the pole and nailed at the seam (Figure 3). It was suspected that the PVC sheet covering material alone could act as a deterrent, thus we also evaluated the

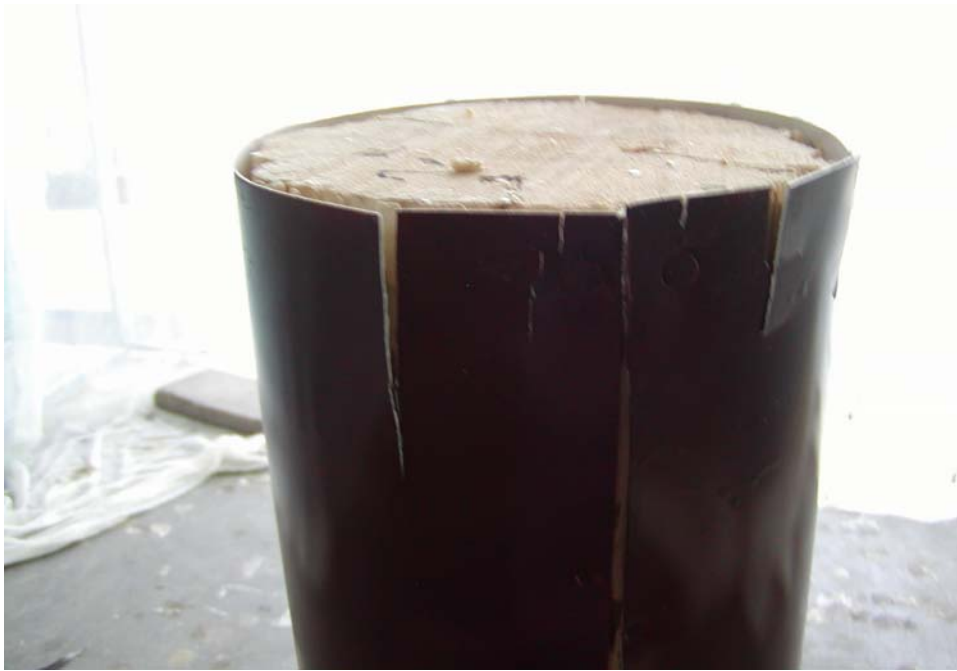
Figure 4: Painted PVC sheeting. This is the same type of sheet material the epoxy resin was applied to. Material was painted to mimic the epoxy treated wrap poles.

same material without the layer of Sniff ‘N’ Stop. This material was painted to match the color of the Sniff ‘N’ Stop (Figure 4).

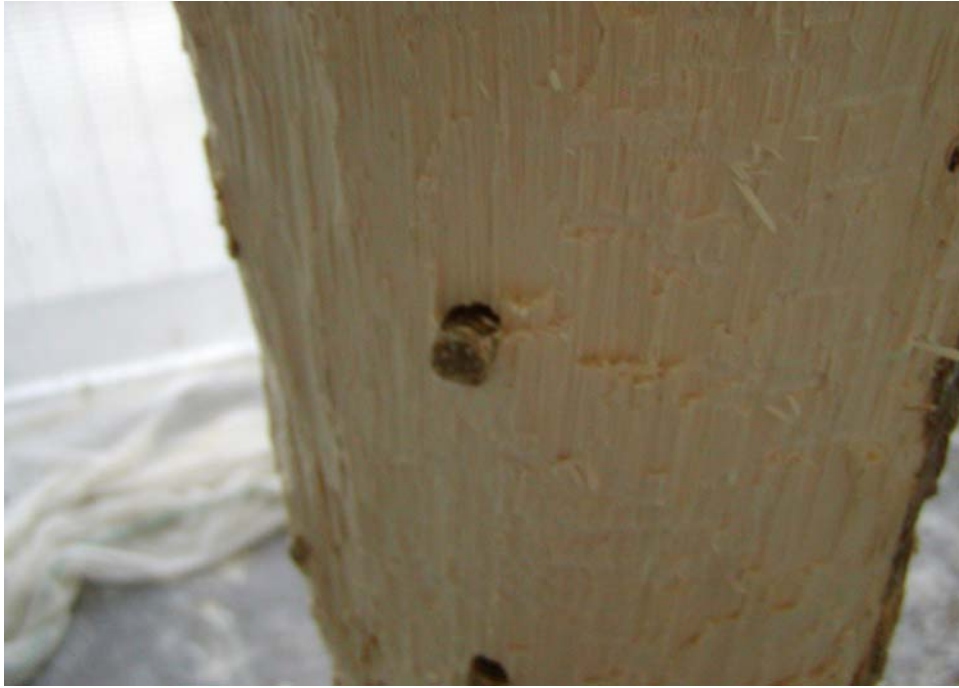
Figure 5: Plug treatment with signs of extensive amounts of pole damage surrounding the plug. Plug showed no effect on reducing the amount of wood removed from untreated surfaces adjacent to the plugs.

Based upon the statistical analysis the plug treatment, at 7.6 cm spacing, appeared to have no effect on the amount of wood removed by woodpeckers. The plugs themselves were rarely damaged but woodpeckers removed wood surrounding each plug to varying degrees. This indicates that the plug treatment did not produce any aversive effects that caused woodpeckers to avoid the area adjacent to the plugs on the pole

section (Figure 5). However, varying the spacing and the size of the plugs warrants further investigation because of the practical and economic benefits of this type of pole treatment.

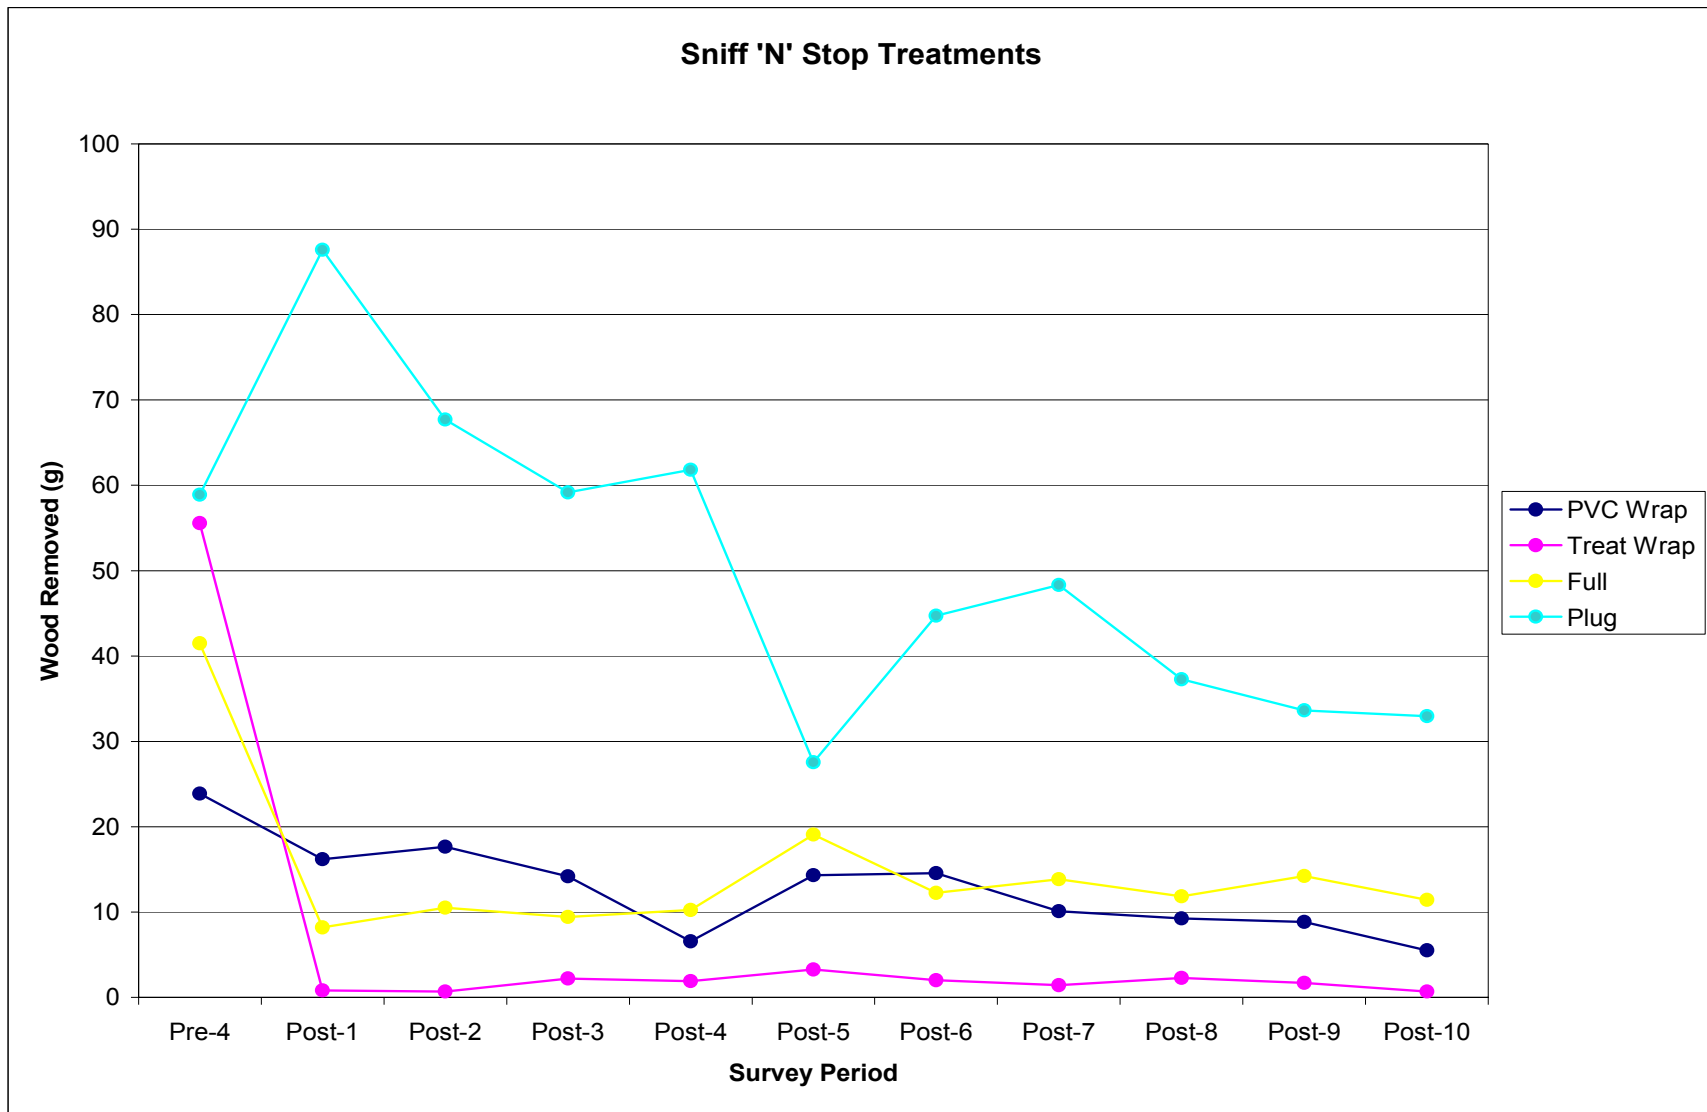
Figure 6: Wood removed by woodpeckers by treatment. Damage values are the mean daily values for all birds exposed to each of the Sniff 'N' Stop and PVC wrap treatments.

A descriptive analysis of the data showed that the three treatment applications of Sniff 'N' Stop deterrent reduced woodpecker damage to respective pole sections (Figure 6).

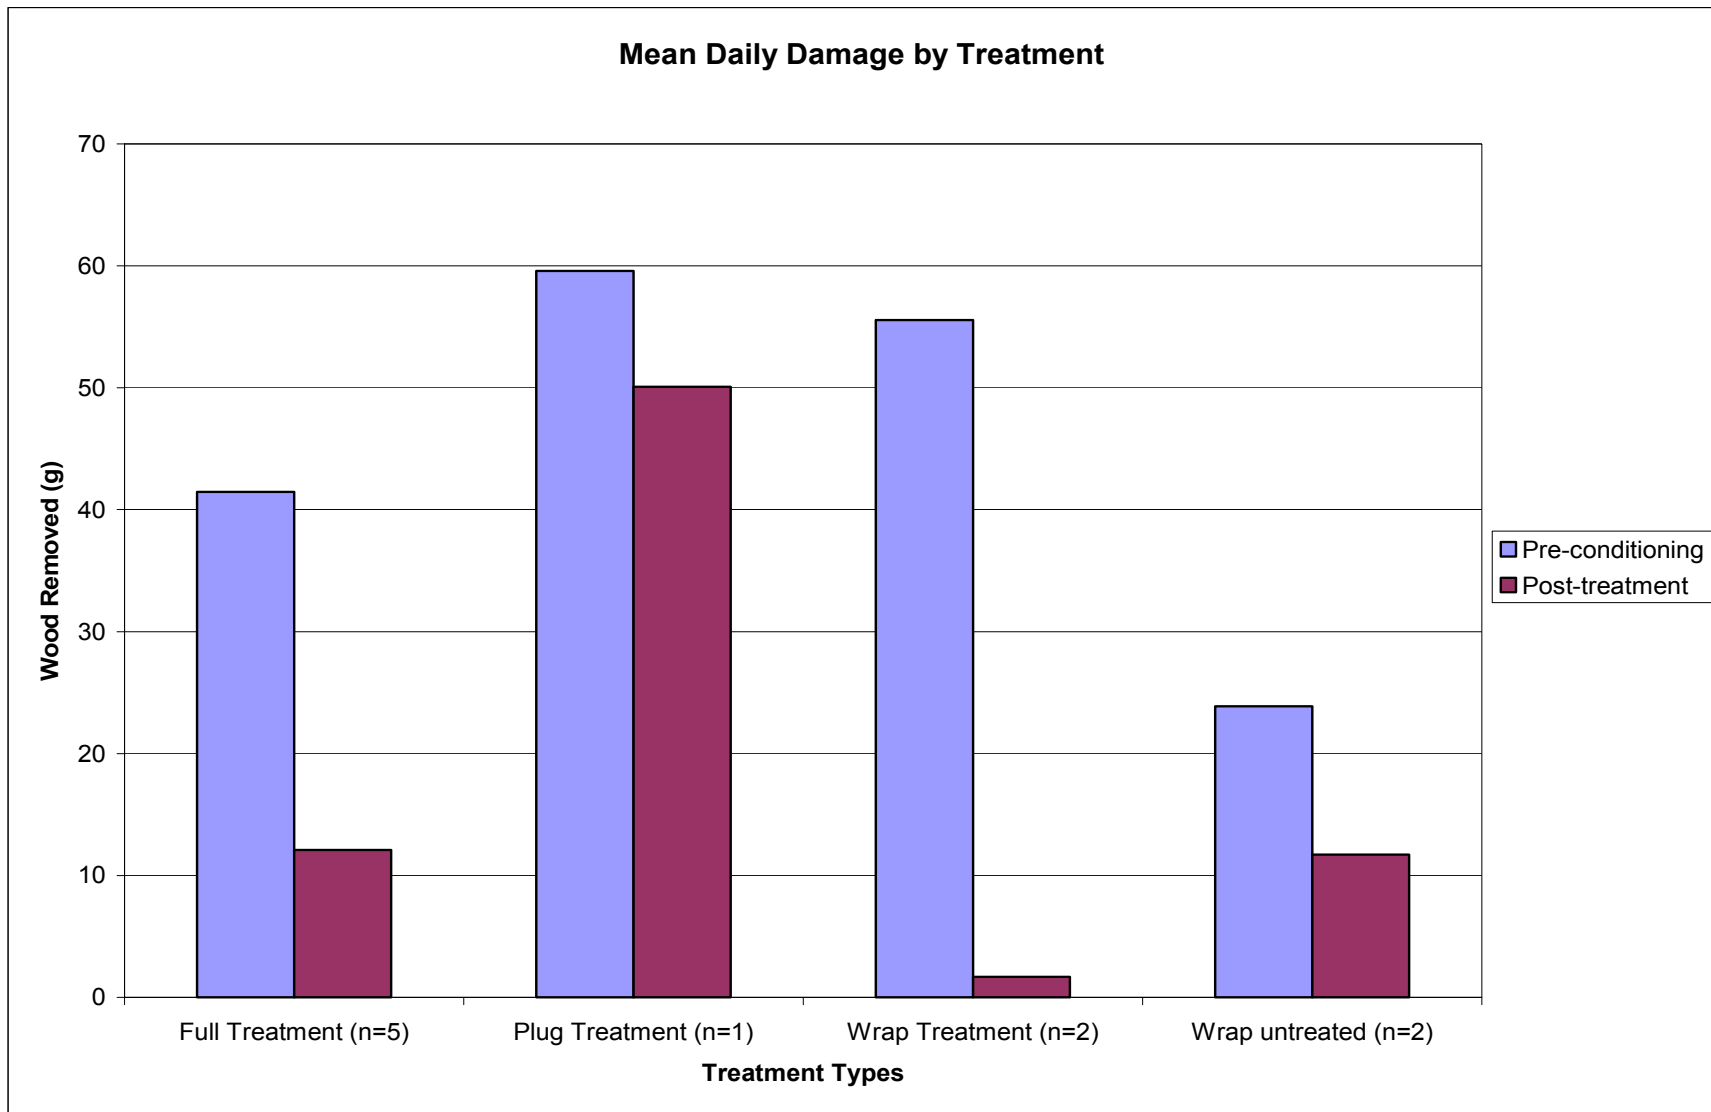
Figure 7: Mean daily amount of wood removed by treatments for the three Sniff 'N' Stop deterrents and the untreated PVC control wrap.

The amount of wood removed by woodpeckers from pole sections ($n=5$) treated with a full application of Sniff 'N' Stop deterrent decreased from an average of 41.5 g of wood removed the last day of pre-conditioning period to an average of 12.1 g of wood removed each day during the post-treatment period (Figure 7). This amounted to a 71% reduction in wood removed (Figure 8). The amount of wood removed decreased from the last pre-conditioning day through the post-treatment period (Figure 9), but there was a high degree of variability in the amount of wood removed among poles and over days (Figures 10-14). In two cases, there was little change from pre to post-treatment amounts of wood removed (Figures 12-13), and both of these birds produced some post-treatment damage that was higher than the last pre-conditioning day. Three of the woodpeckers, when exposed to a fully treated pole, showed an immediate decrease in the amount of

The amount of wood removed by woodpeckers from poles treated with the wrap application (n=2) of Sniff 'N' Stop deterrent decreased from an average of 55.6 g of wood removed the last day of pre-conditioning period to an average of 1.7 g of wood removed each day during the post-treatment period (Figure 7). This amounted to a 97% reduction in mean daily amount of wood removed (Figure 8). The amount of wood removed from both Sniff 'N' Stop treated wraps was similar during the pre-conditioning and post-treatment periods (Figures 17-19).

The amount of wood removed by woodpeckers from poles treated with the PVC wrap decreased from an average of 23.9 grams of wood removed the last day of pre-conditioning period to an average of 11.7 g of wood removed each day during the post-treatment period (Figure 7). This amounted to a 51% reduction in wood removed (Figure 8). Significant variability between the two PVC wraps made it difficult to determine if there was any deterrent effect created by the material (Figure 20). One of the woodpeckers exposed to the PVC wrap removed less post-treatment amounts of wood than any other bird on test (Figure 21). The other bird, which was exposed to the PVC wrap, increased the amount of wood removed during the post-treatment (Figure 22).

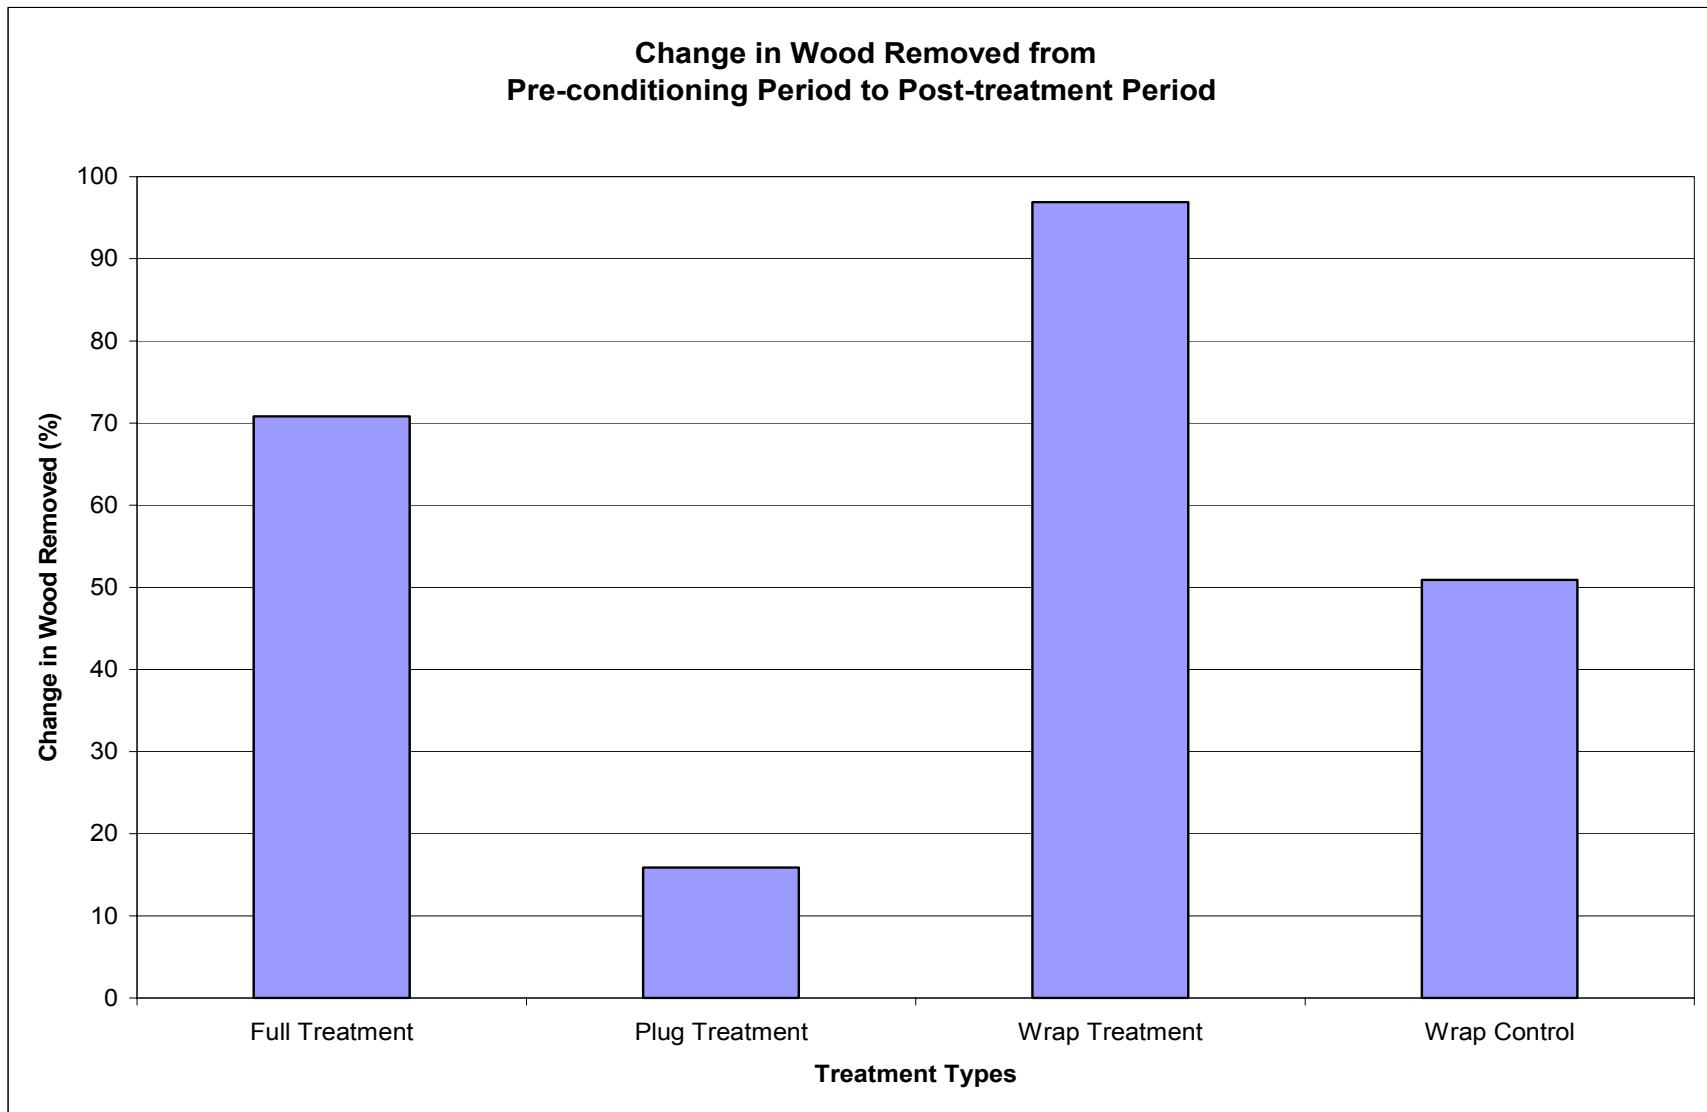
Figure 8: Change in the mean amount of wood removed from the pre-conditioning to post-treatment period for the three Sniff ‘N’ Stop deterrents and the untreated PVC control wrap.

The amount of wood removed by woodpeckers from poles treated with the plug application (n=1) decreased from 58.9 g of wood removed the last day of the pre-conditioning period to an average of 50.1 g of wood removed each day during the post-treatment period (Figures 15 and 16). This amounted to a 15% reduction in wood removed (Figure 8).

There were no statistical differences between the PVC wrap and the Sniff 'N' Stop treated wrap. The descriptive statistics showed that non-significant numerical differences between the treated and untreated wraps exist. The Sniff 'N' Stop treated wraps produced substantially less post-treatment damage than the PVC wraps (Figure 8). This suggests that the treated wrap protected wood surfaces better than untreated PVC wrap.

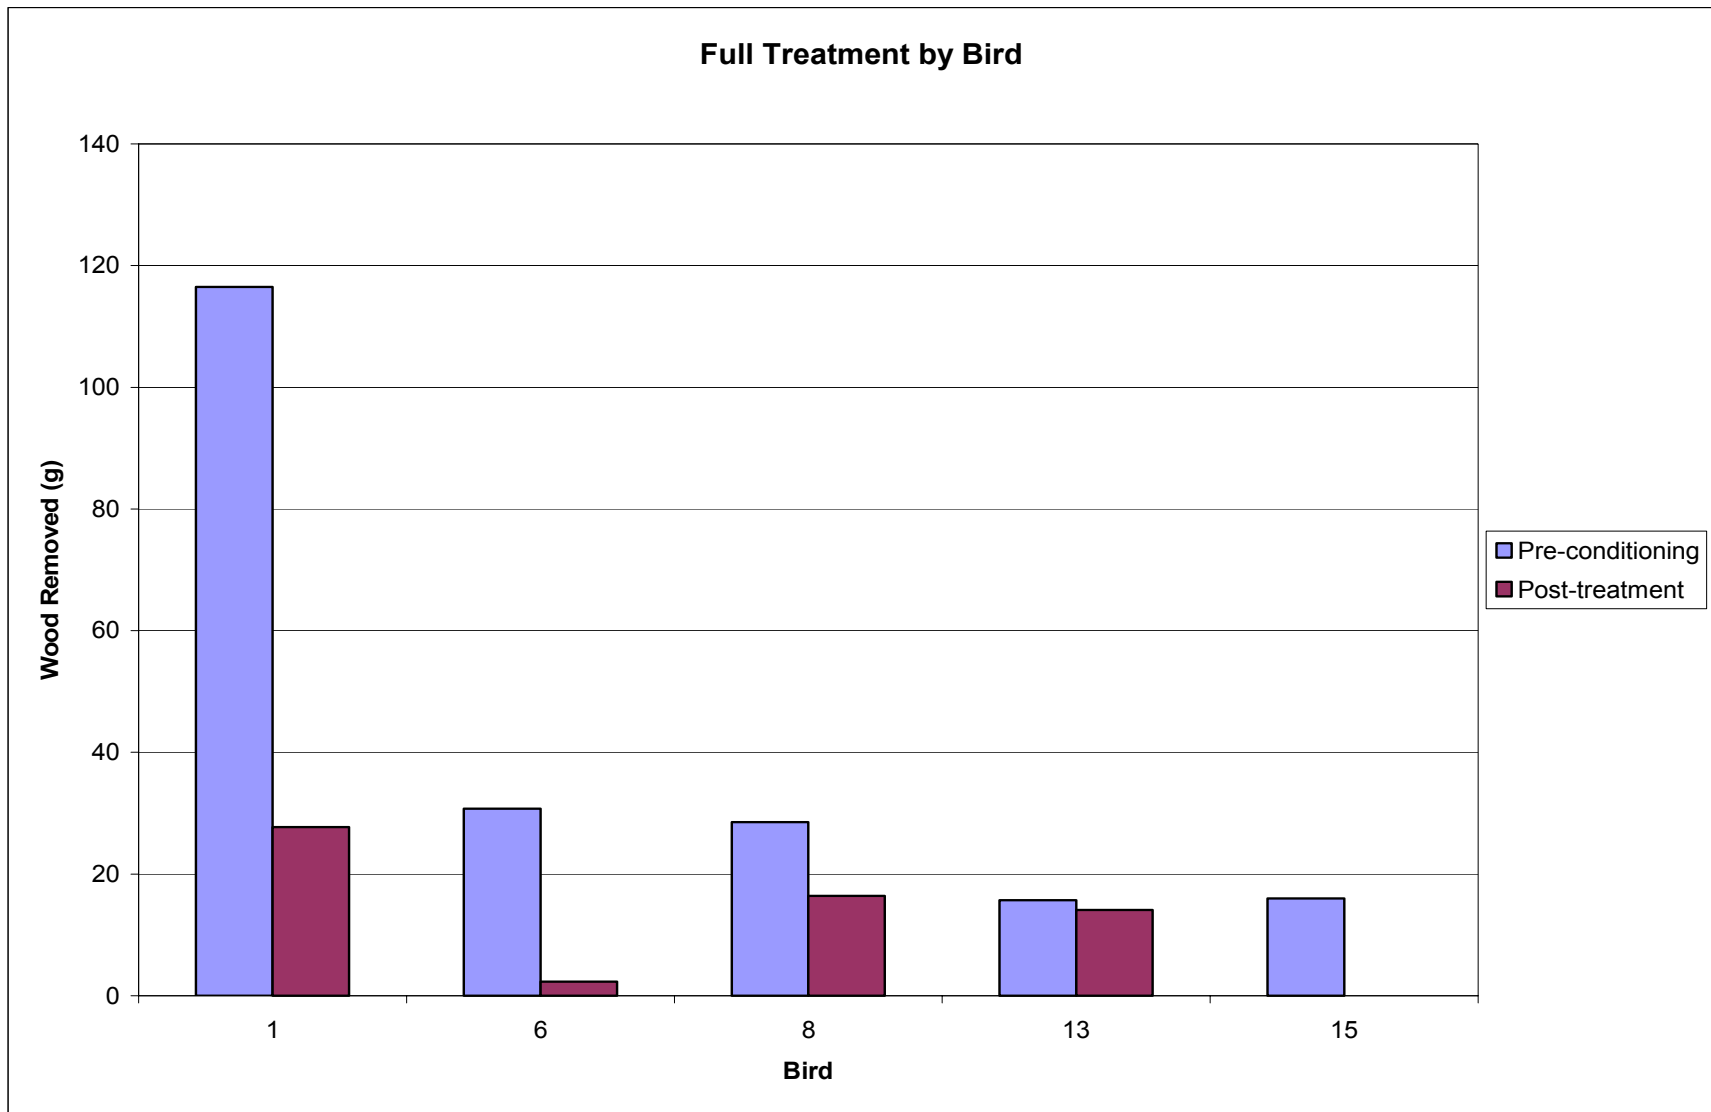
Figure 9: Amount of wood removed by woodpeckers from pole section treated with Sniff 'N' Stop deterrent.

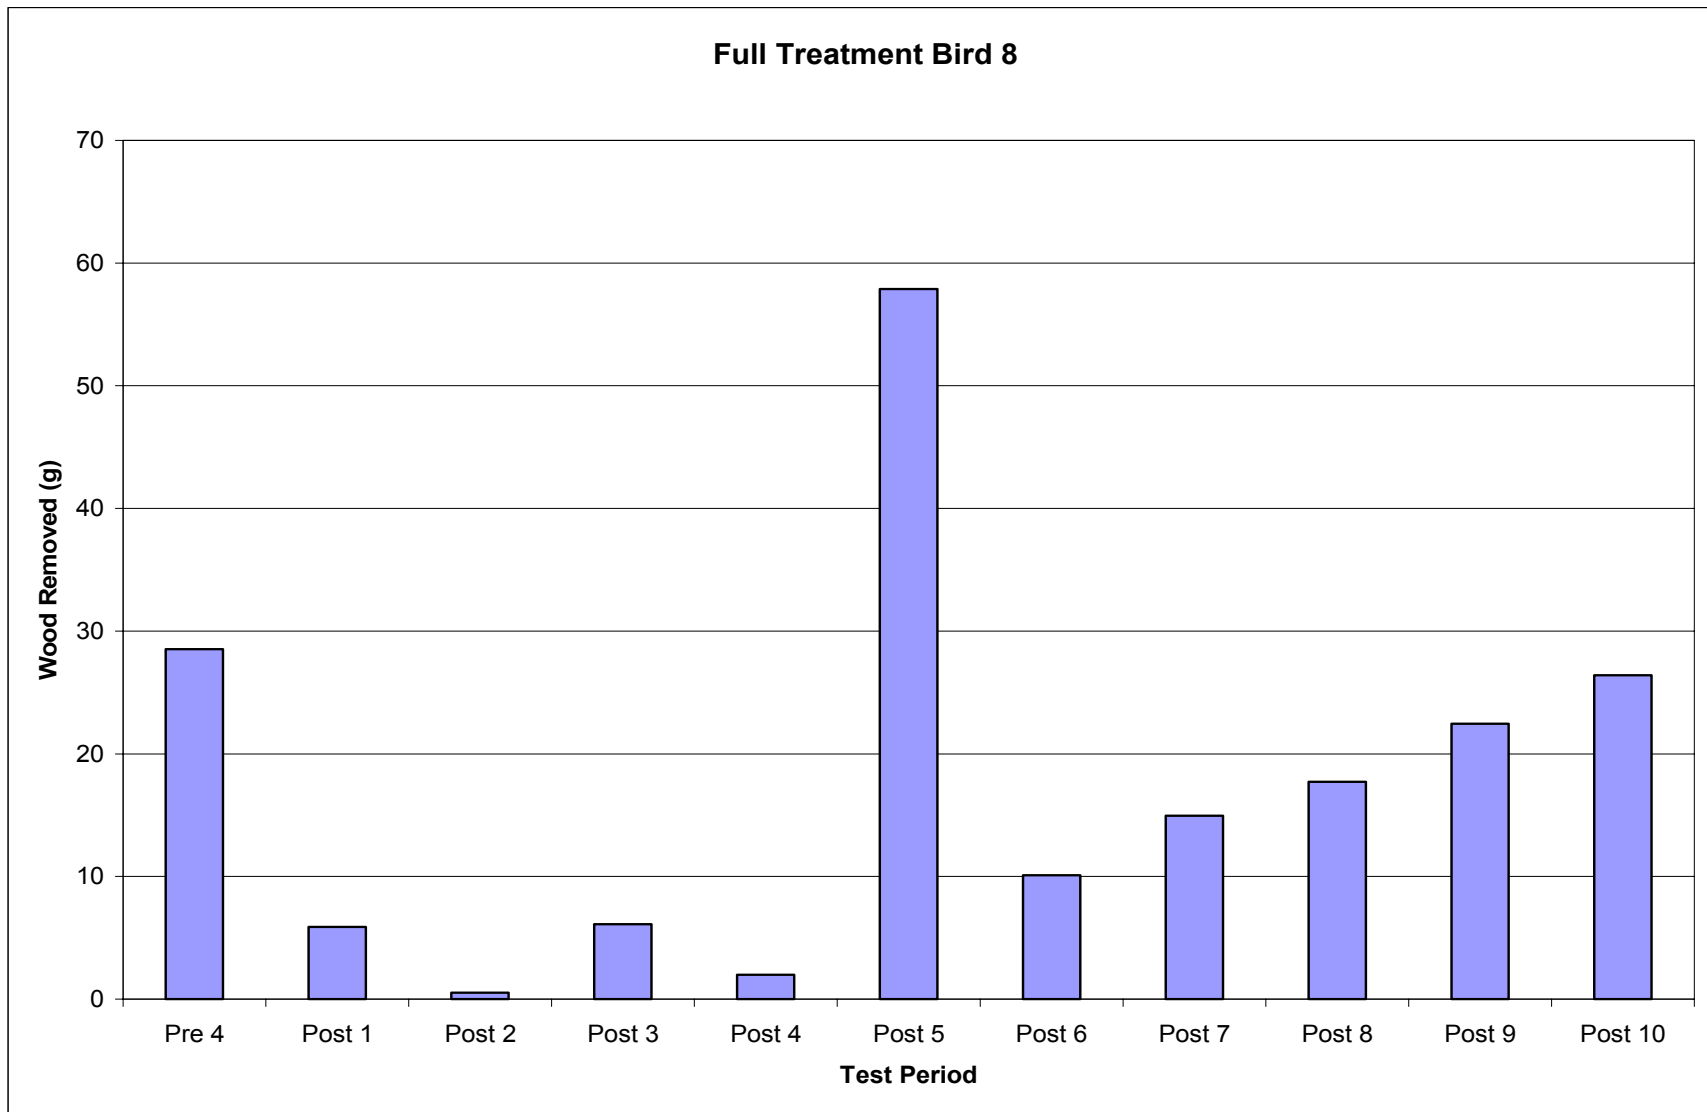
Figure 12: Daily amount of wood removed by pileated woodpecker in cage 8 from pole section with a full treatment.

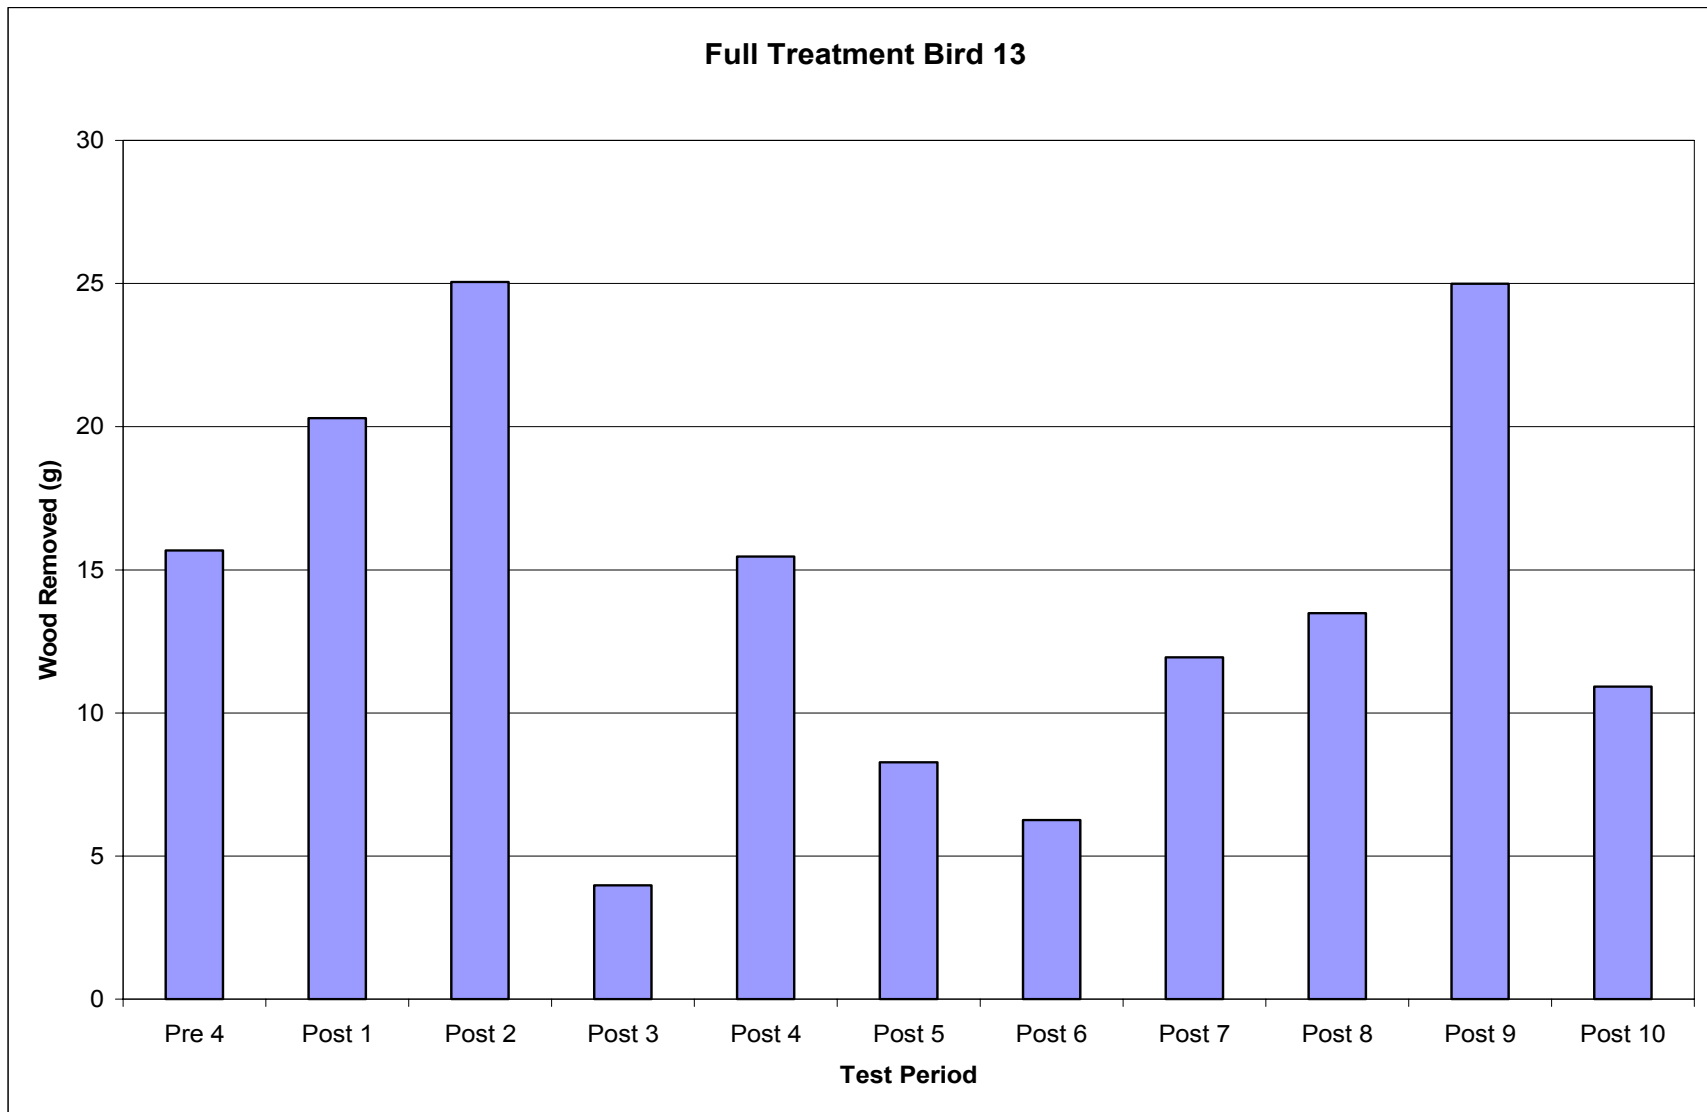
Figure 13: Daily amount of wood removed by pileated woodpecker in cage 13 from pole section with a full treatment.

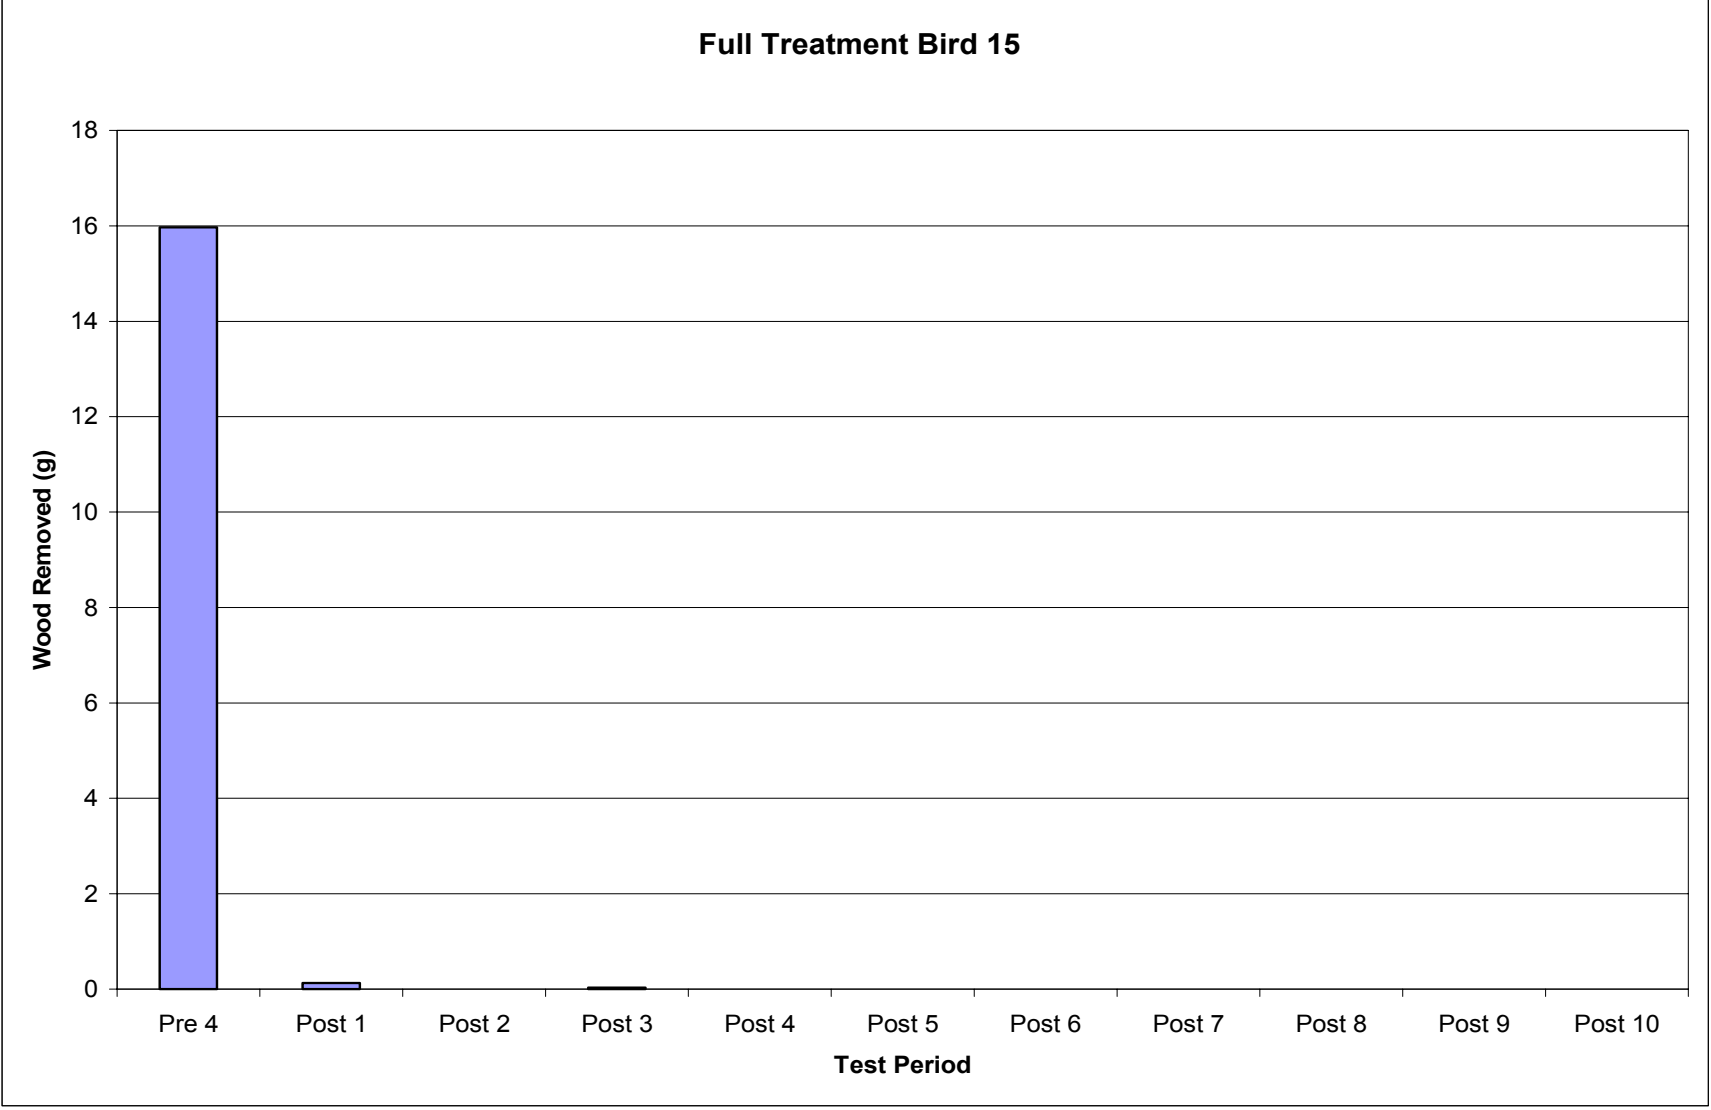
Figure 14: Daily amount of wood removed by pileated woodpecker in cage 15 from pole section with a full treatment.

wood removed which persisted throughout the post-treatment period of the experiment (Figures 10, 11, and 14).

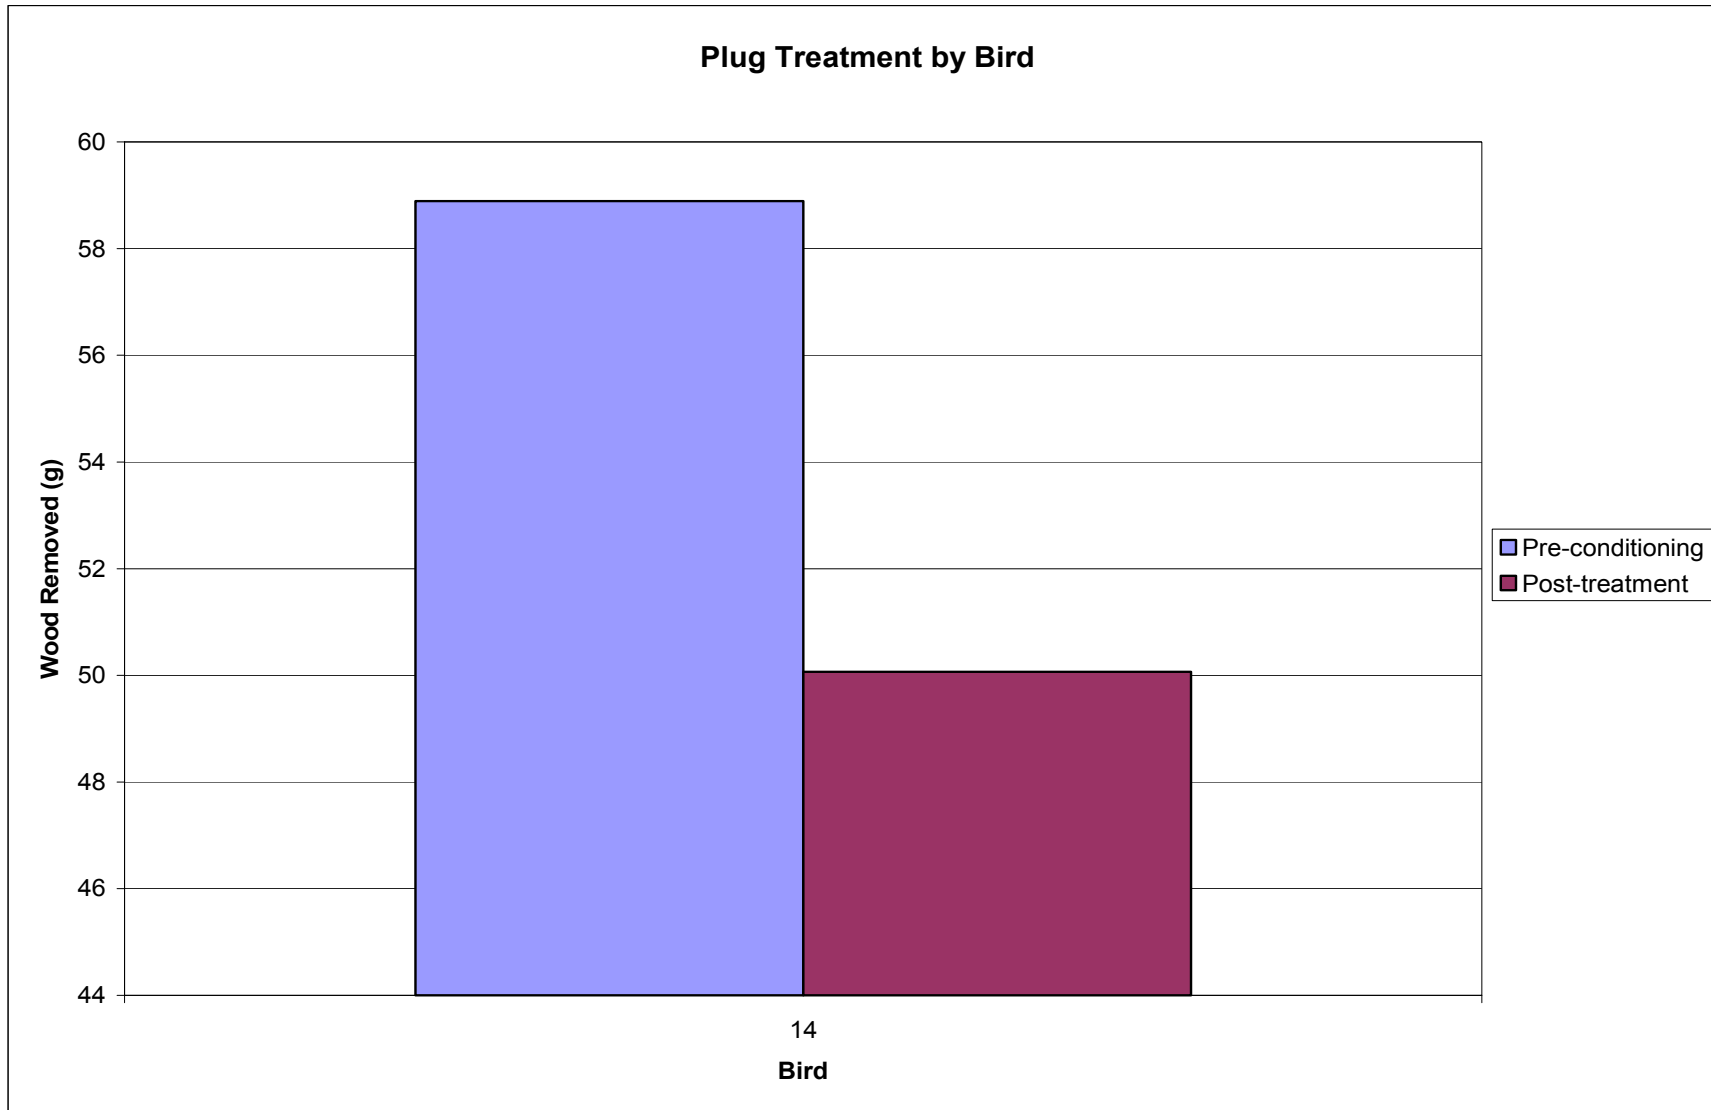
Figure 15: Mean daily amount of wood removed during the pre-conditioning and post-treatment periods for the bird exposed to the plug treatment.

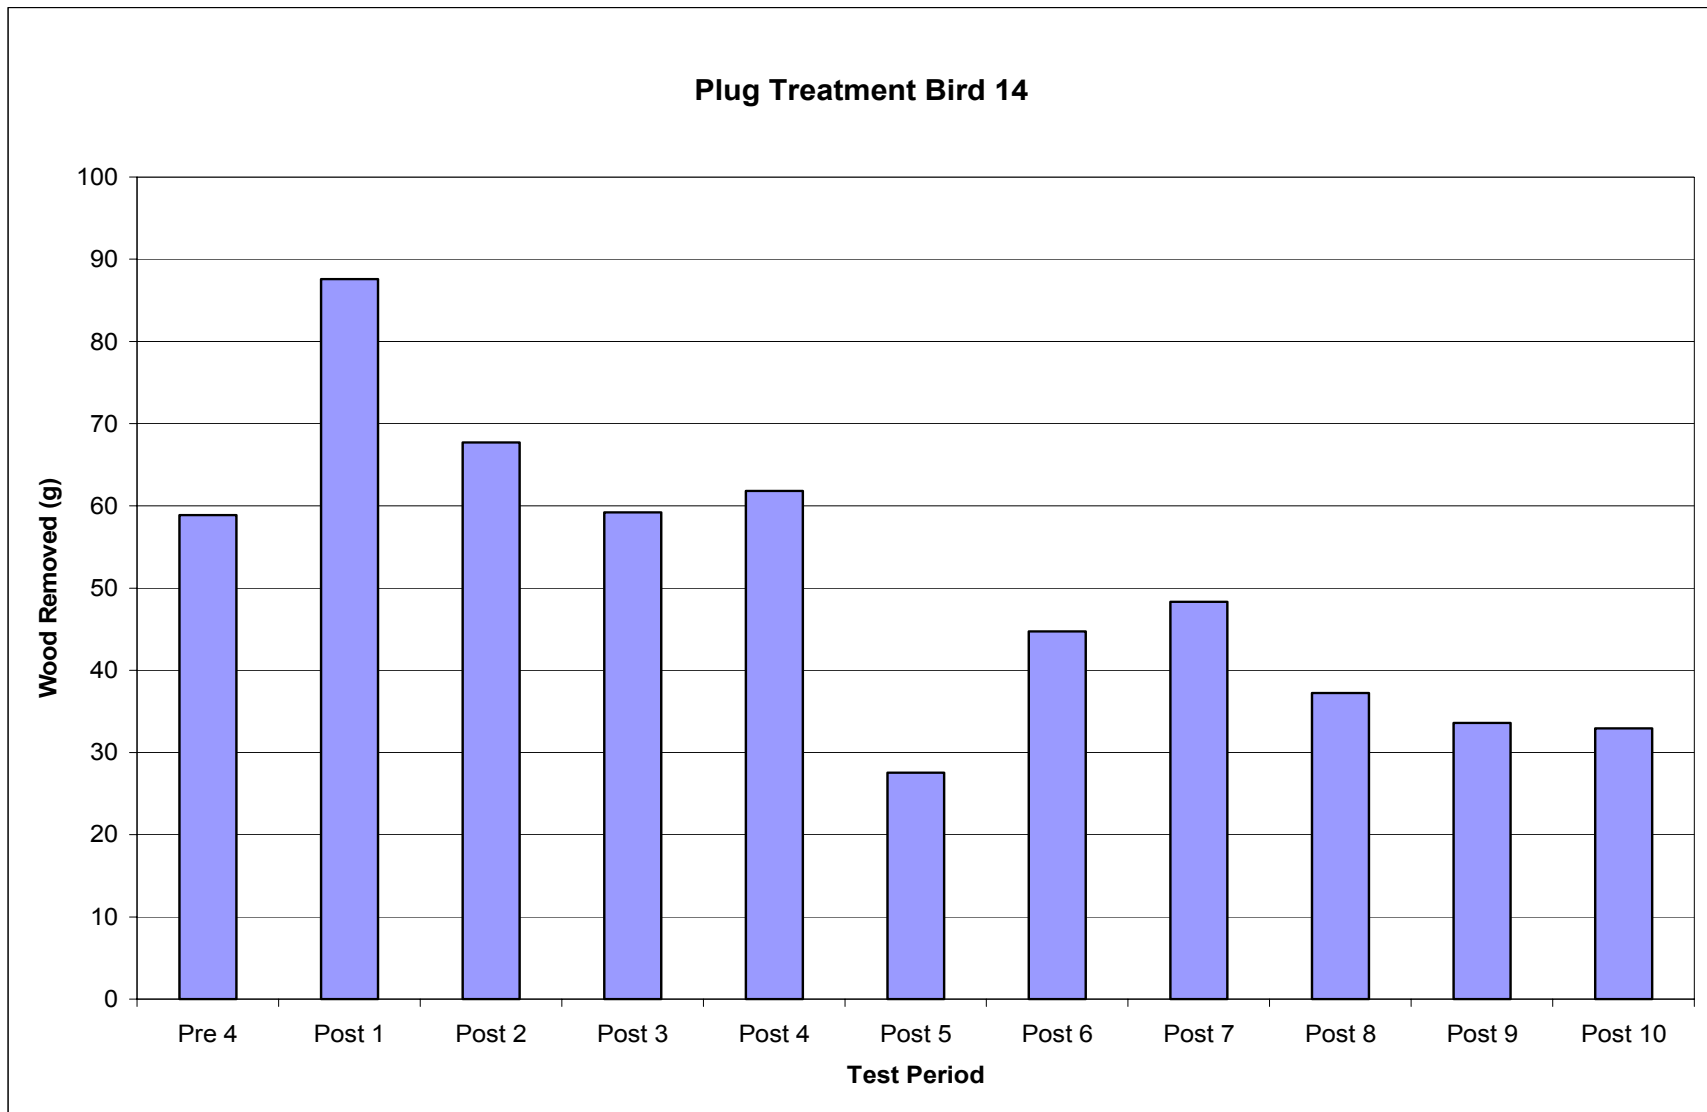
Figure 16: Daily amount of wood removed by pileated woodpecker in cage 14 from pole section with a plug treatment.
