26 July 2004

**Evaluation of IStop™ Cribbing and Chewing Deterrent Product to Reduce Pileated
Woodpecker Damage to Utility Poles**

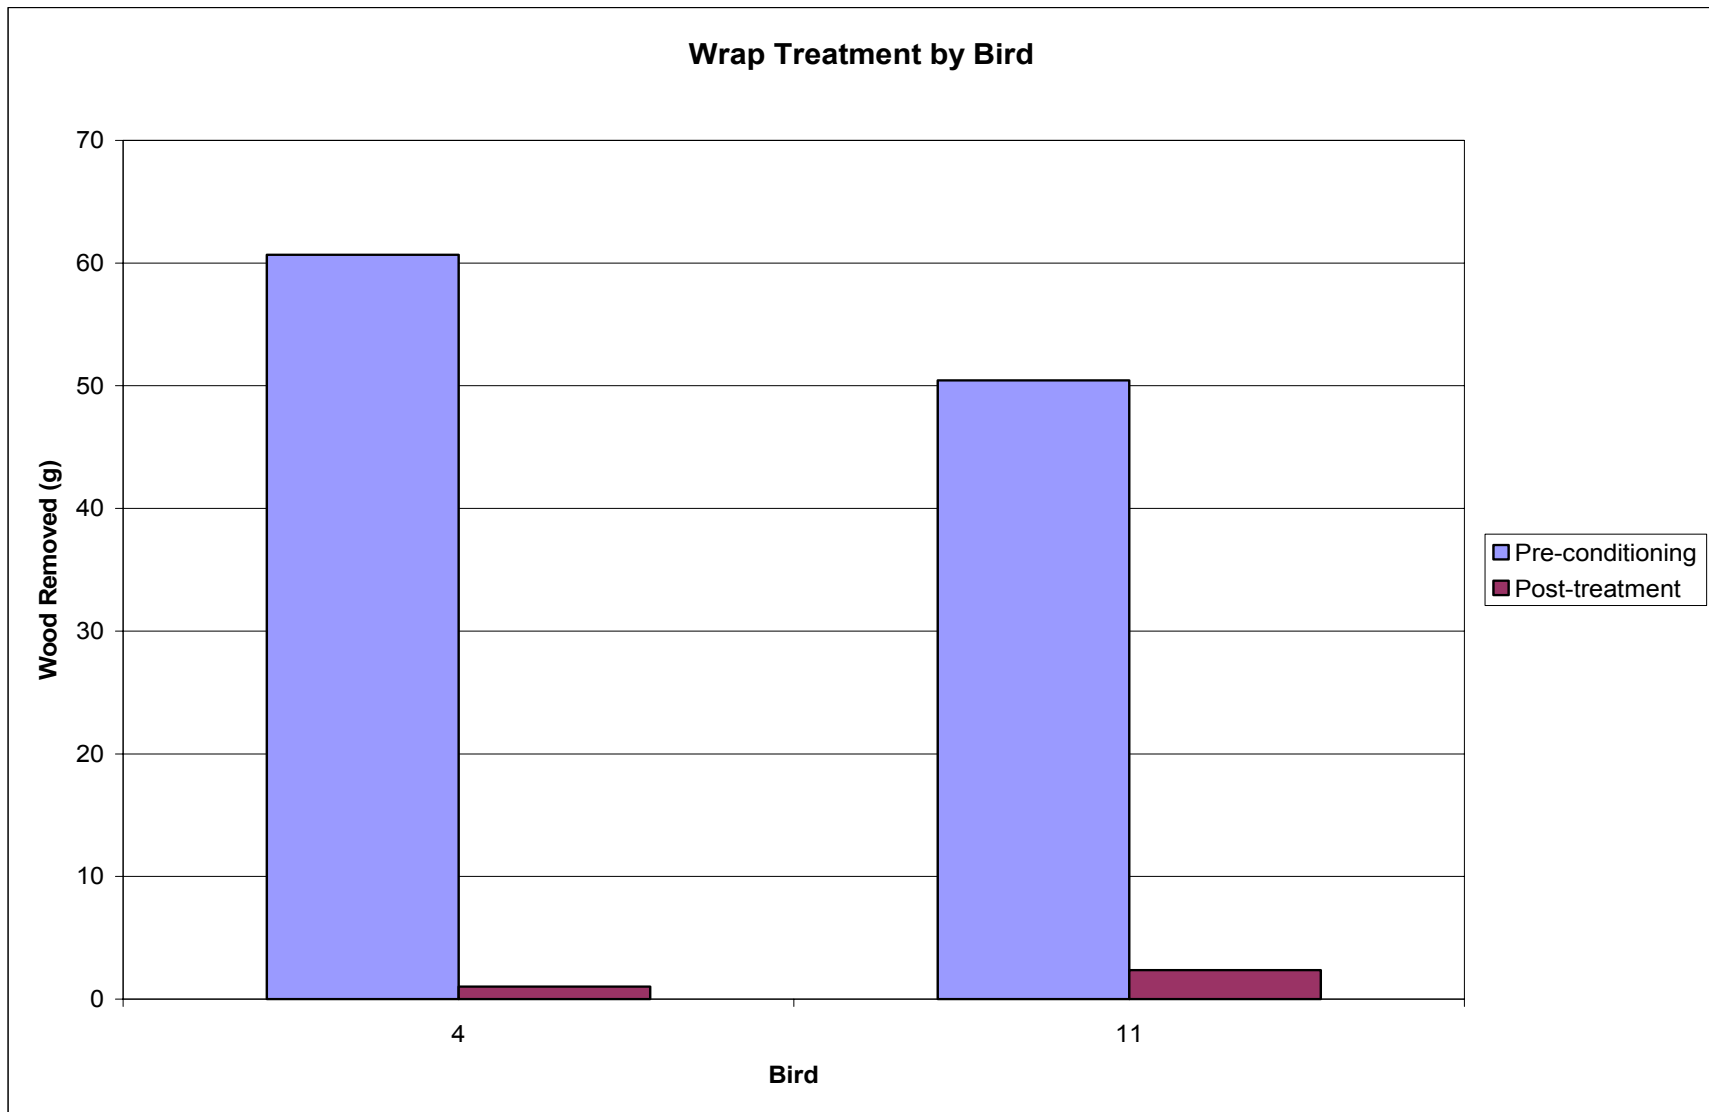
Figure 17: Mean daily amount of wood removed during the pre-conditioning and post-treatment periods for the birds exposed to the wrap treatment.

The amount of wood removed by woodpeckers from poles treated with the wrap application (n=2) of Sniff 'N' Stop deterrent decreased from an average of 55.6 g of wood removed the last day of pre-conditioning period to an average of 1.7 g of wood removed each day during the post-treatment period (Figure 7). This amounted to a 97% reduction in mean daily amount of wood removed (Figure 8). The amount of wood removed from both Sniff 'N' Stop treated wraps was similar during the pre-conditioning and post-treatment periods (Figures 17-19).

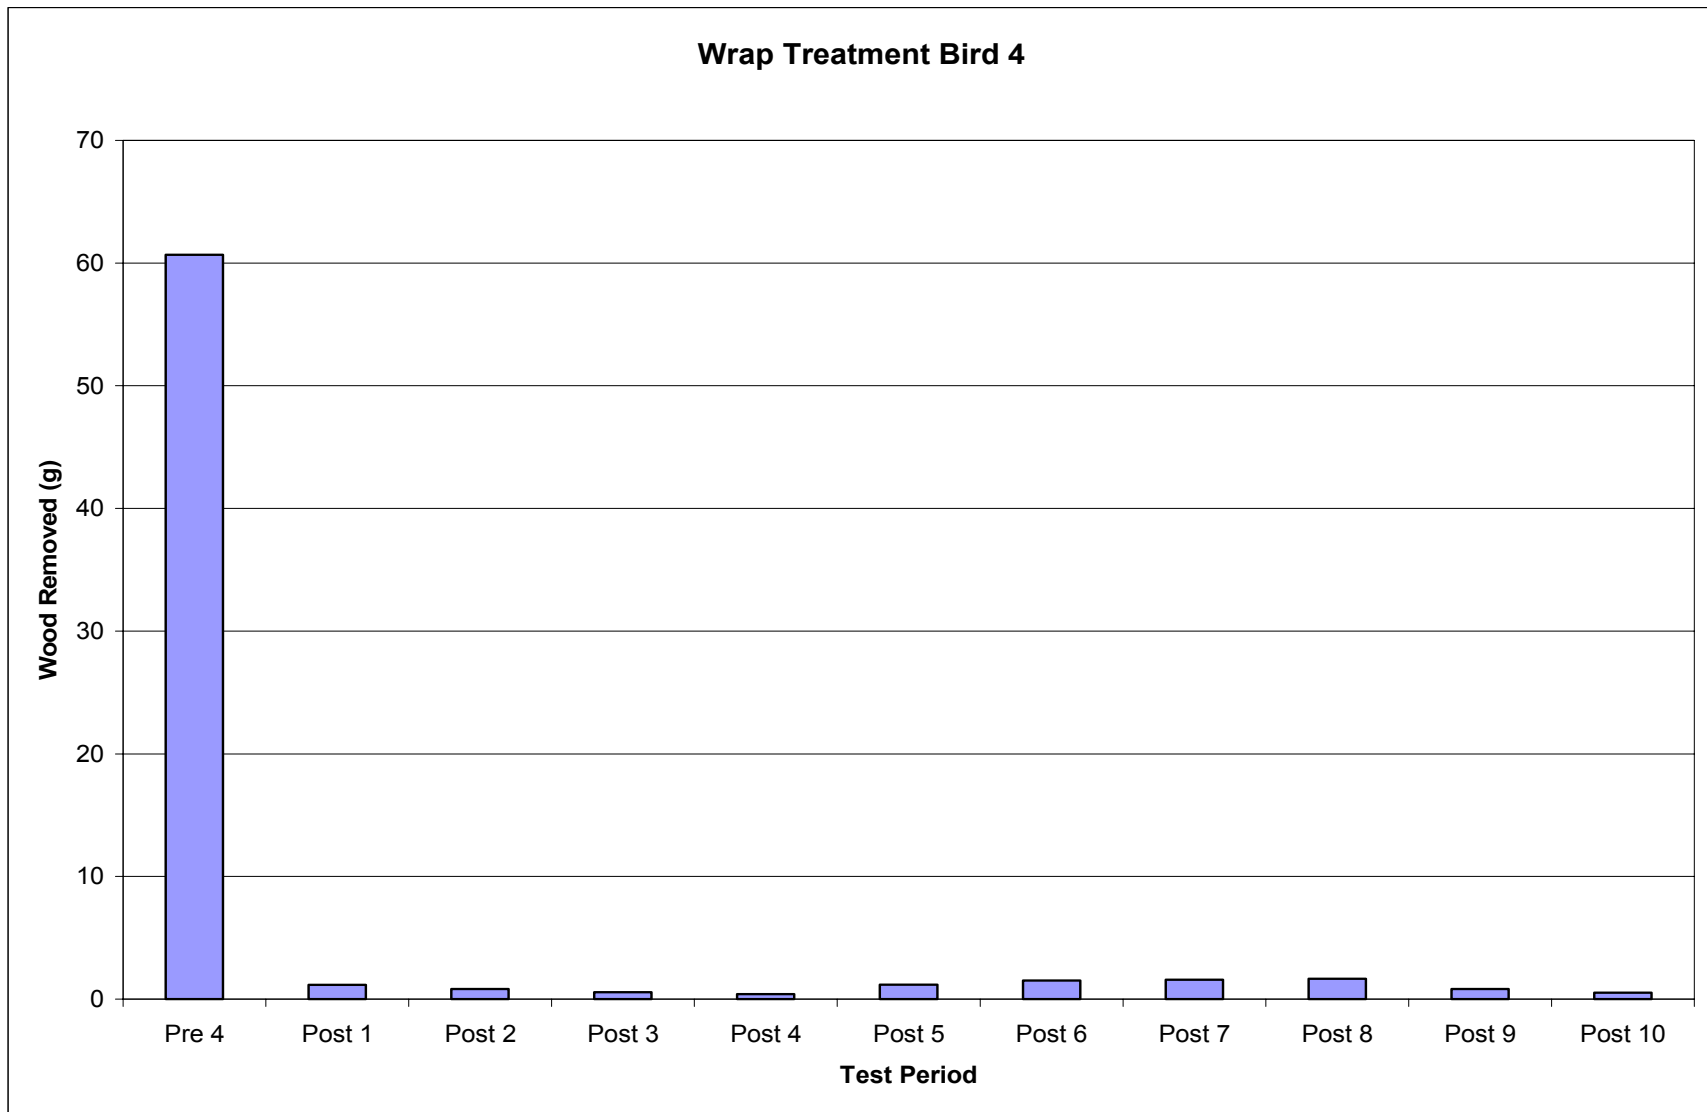
Figure 18: Daily amount of wood removed by pileated woodpecker in cage 4 from pole section with a wrap treatment.

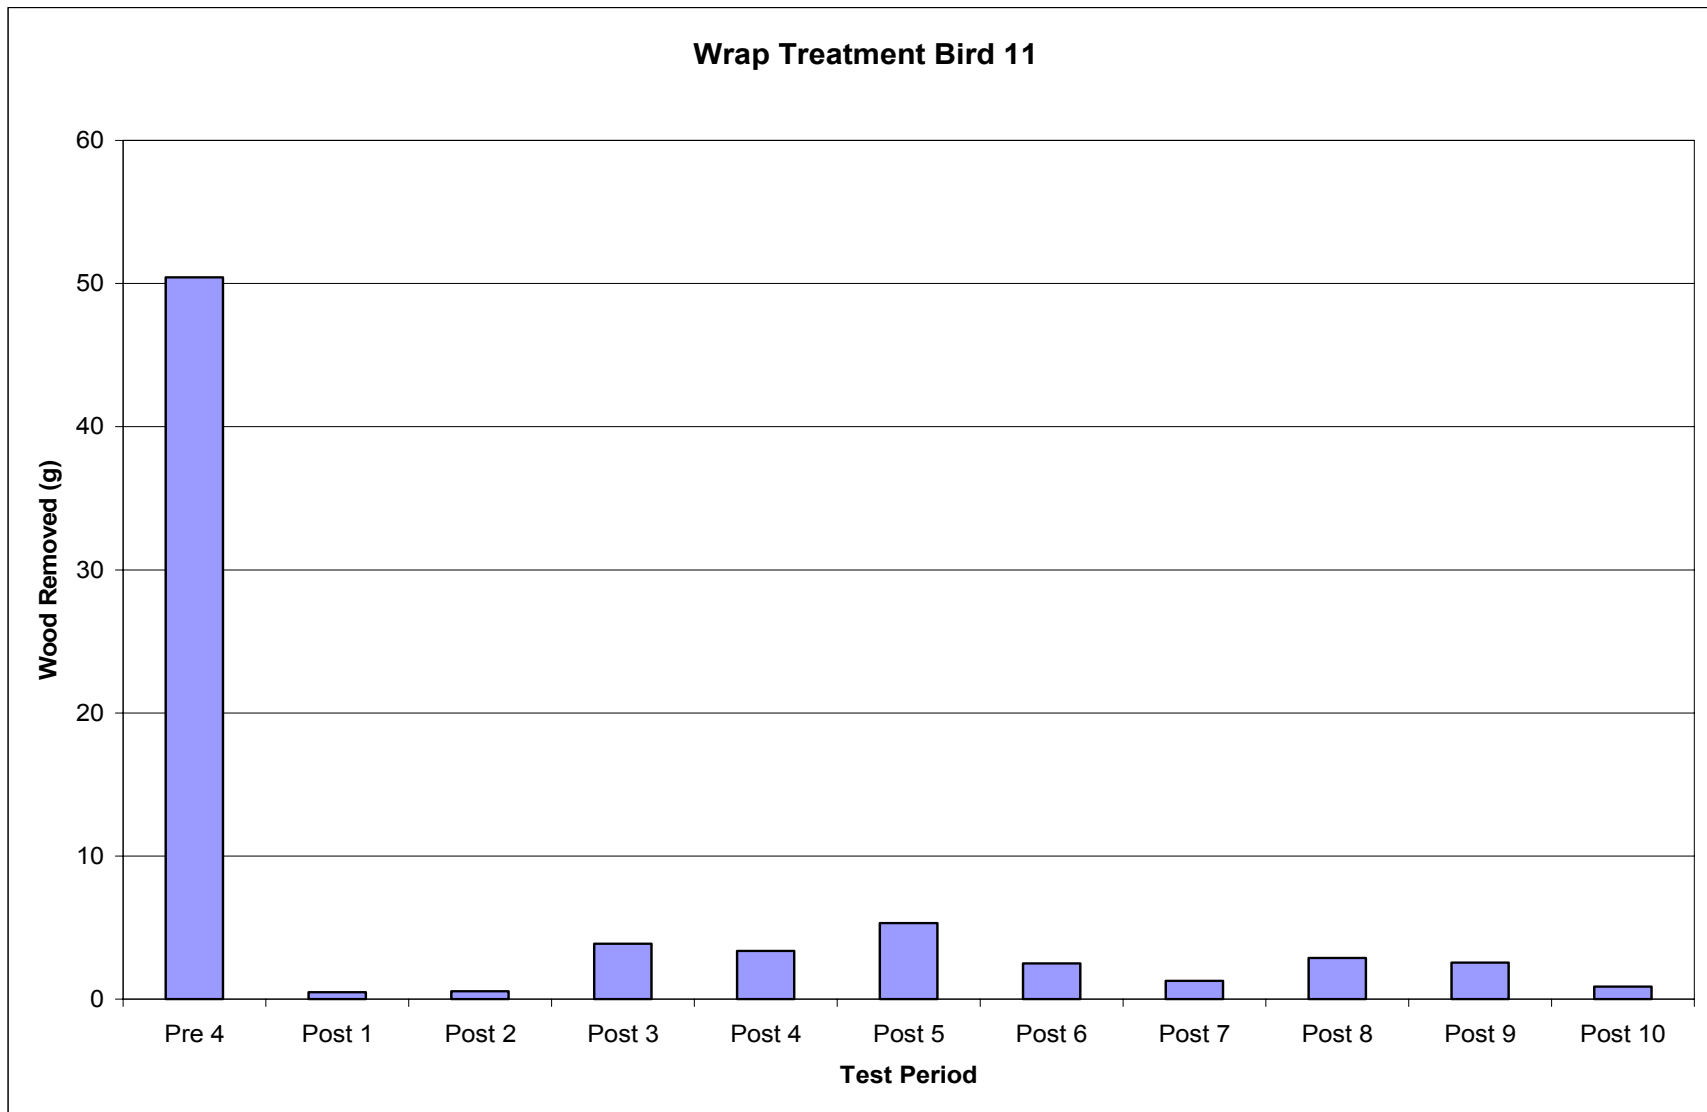
Figure 19: Daily amount of wood removed by pileated woodpecker in cage 11 from pole section with a wrap treatment.

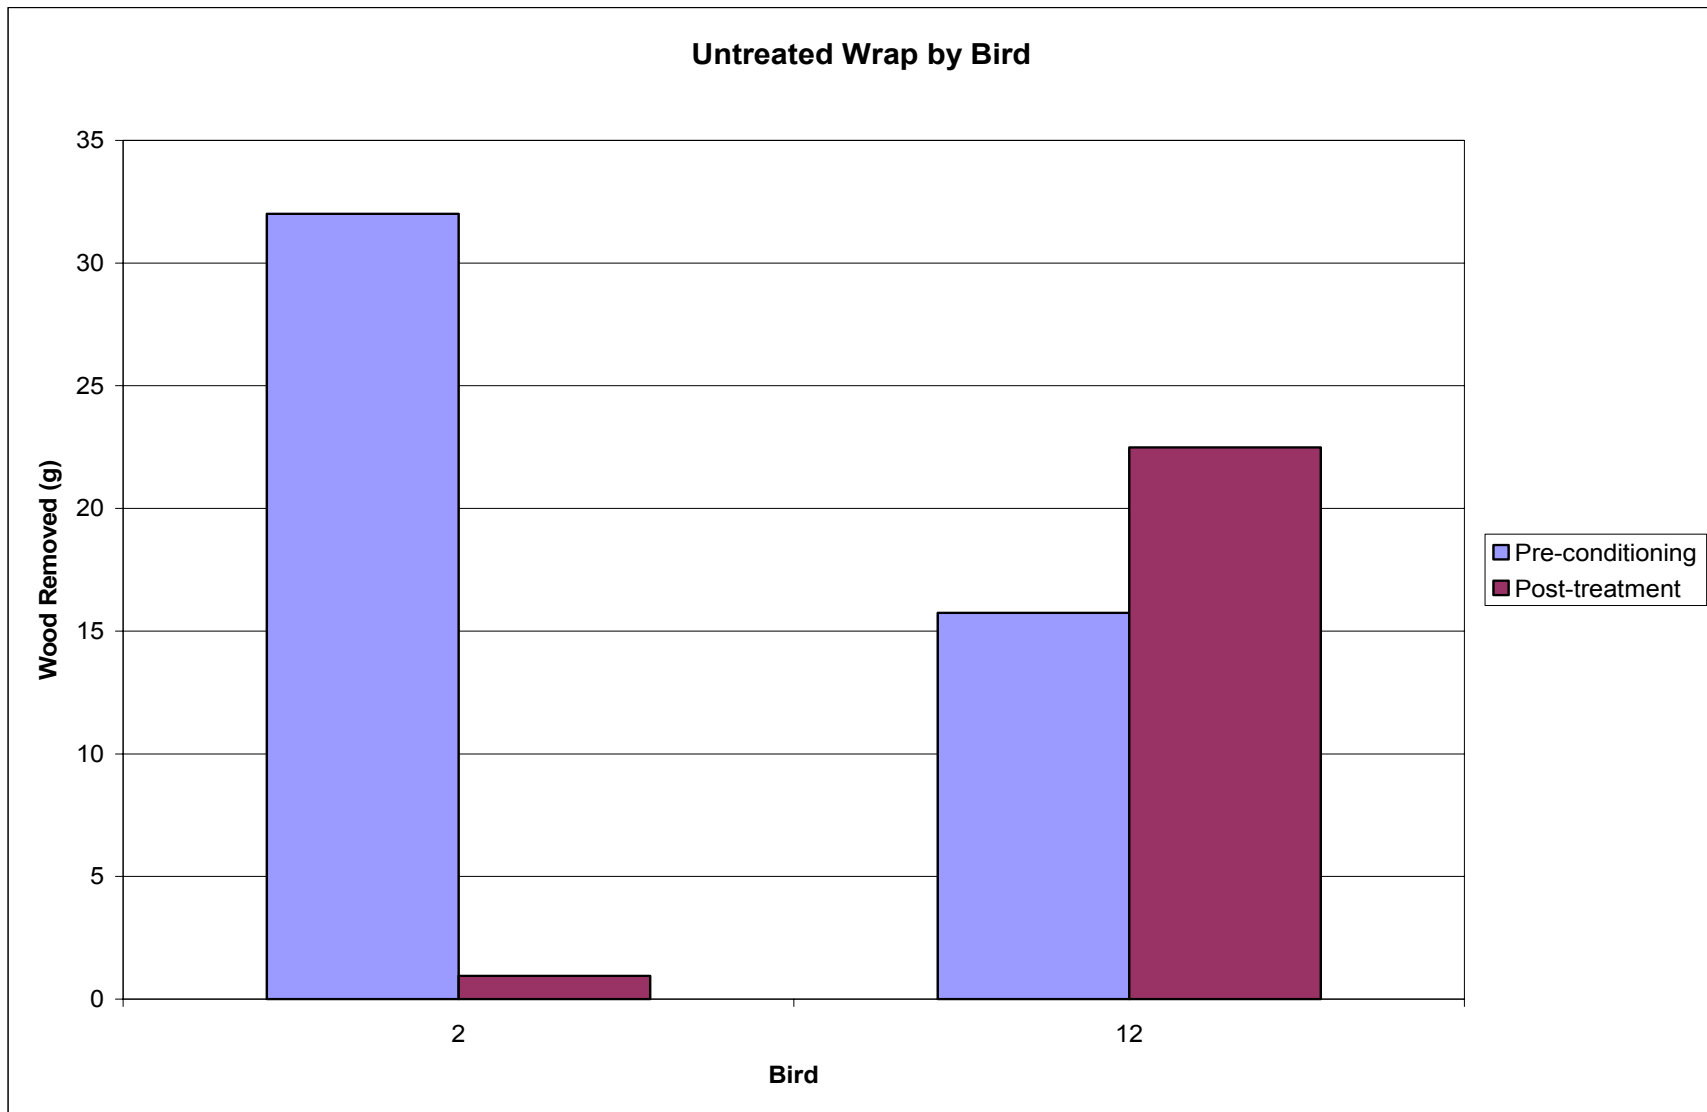
Figure 20: Mean daily amount of wood removed during the pre-conditioning and post-treatment periods for the birds exposed to the untreated wrap treatment.

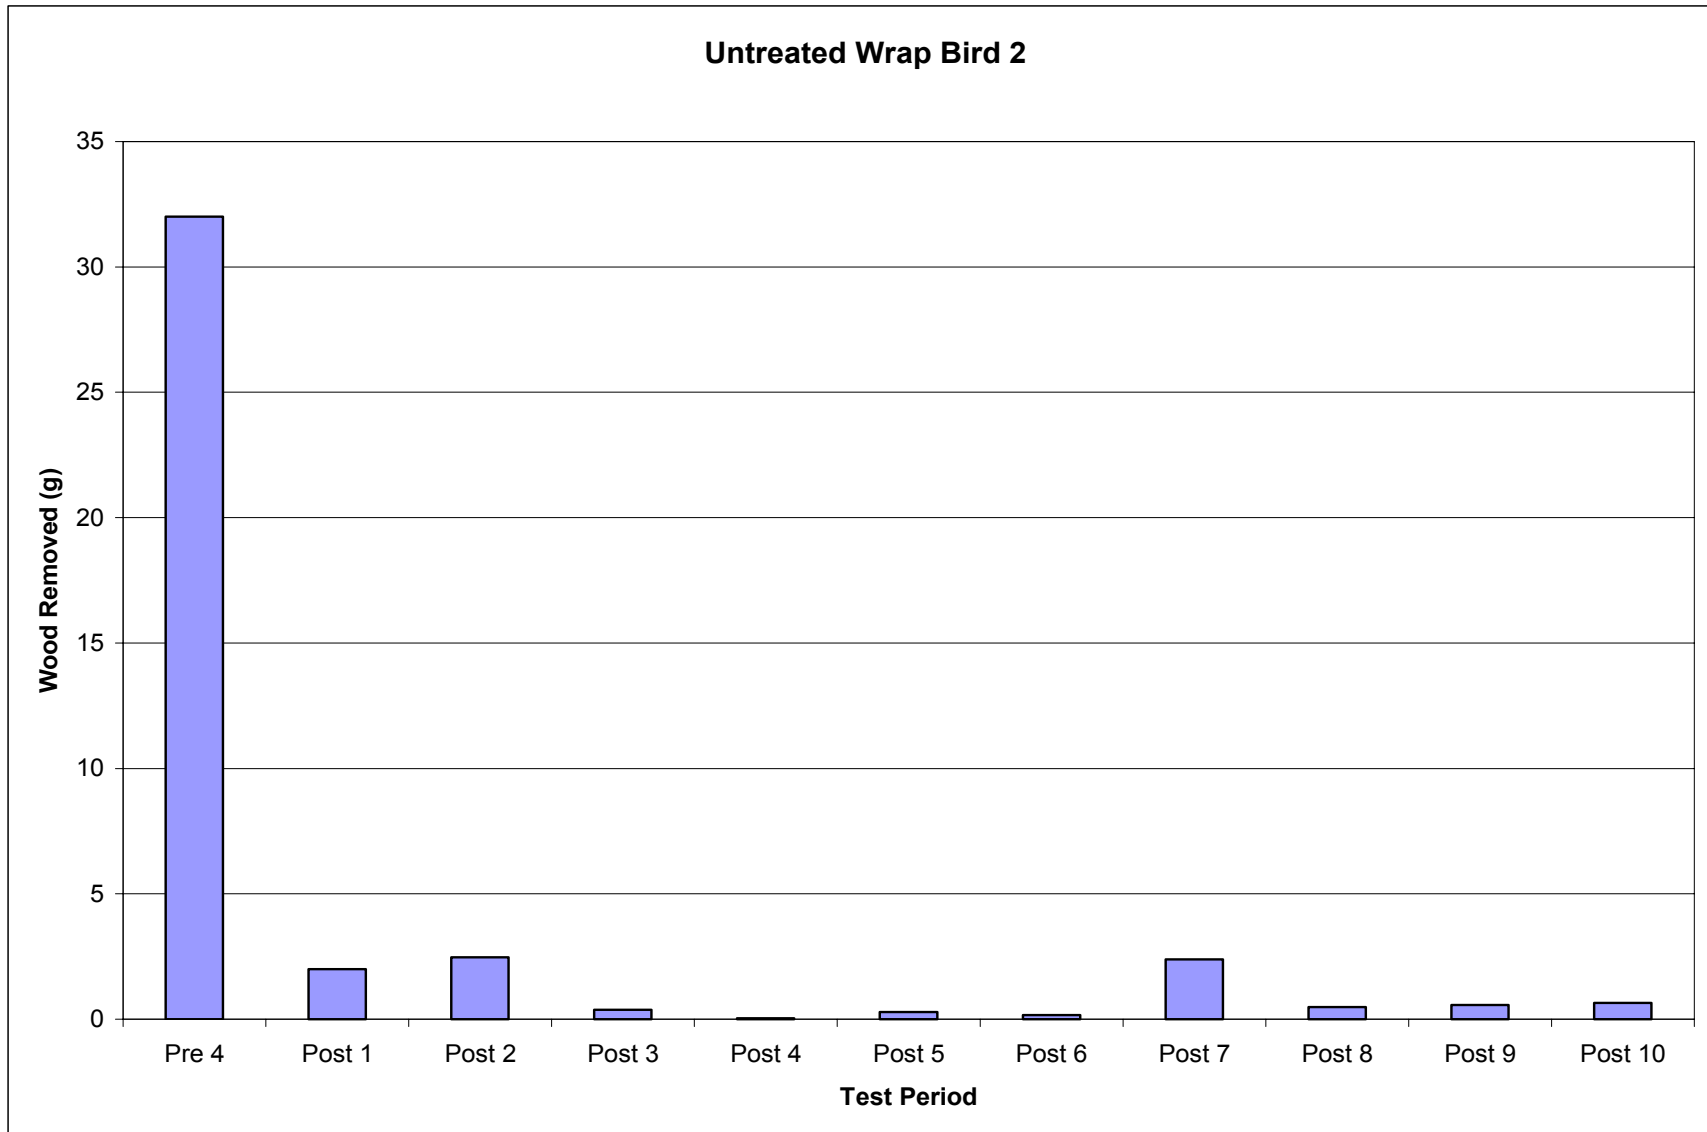
Figure 21: Daily amount of wood removed by pileated woodpecker in cage 2 from pole section with an untreated wrap.

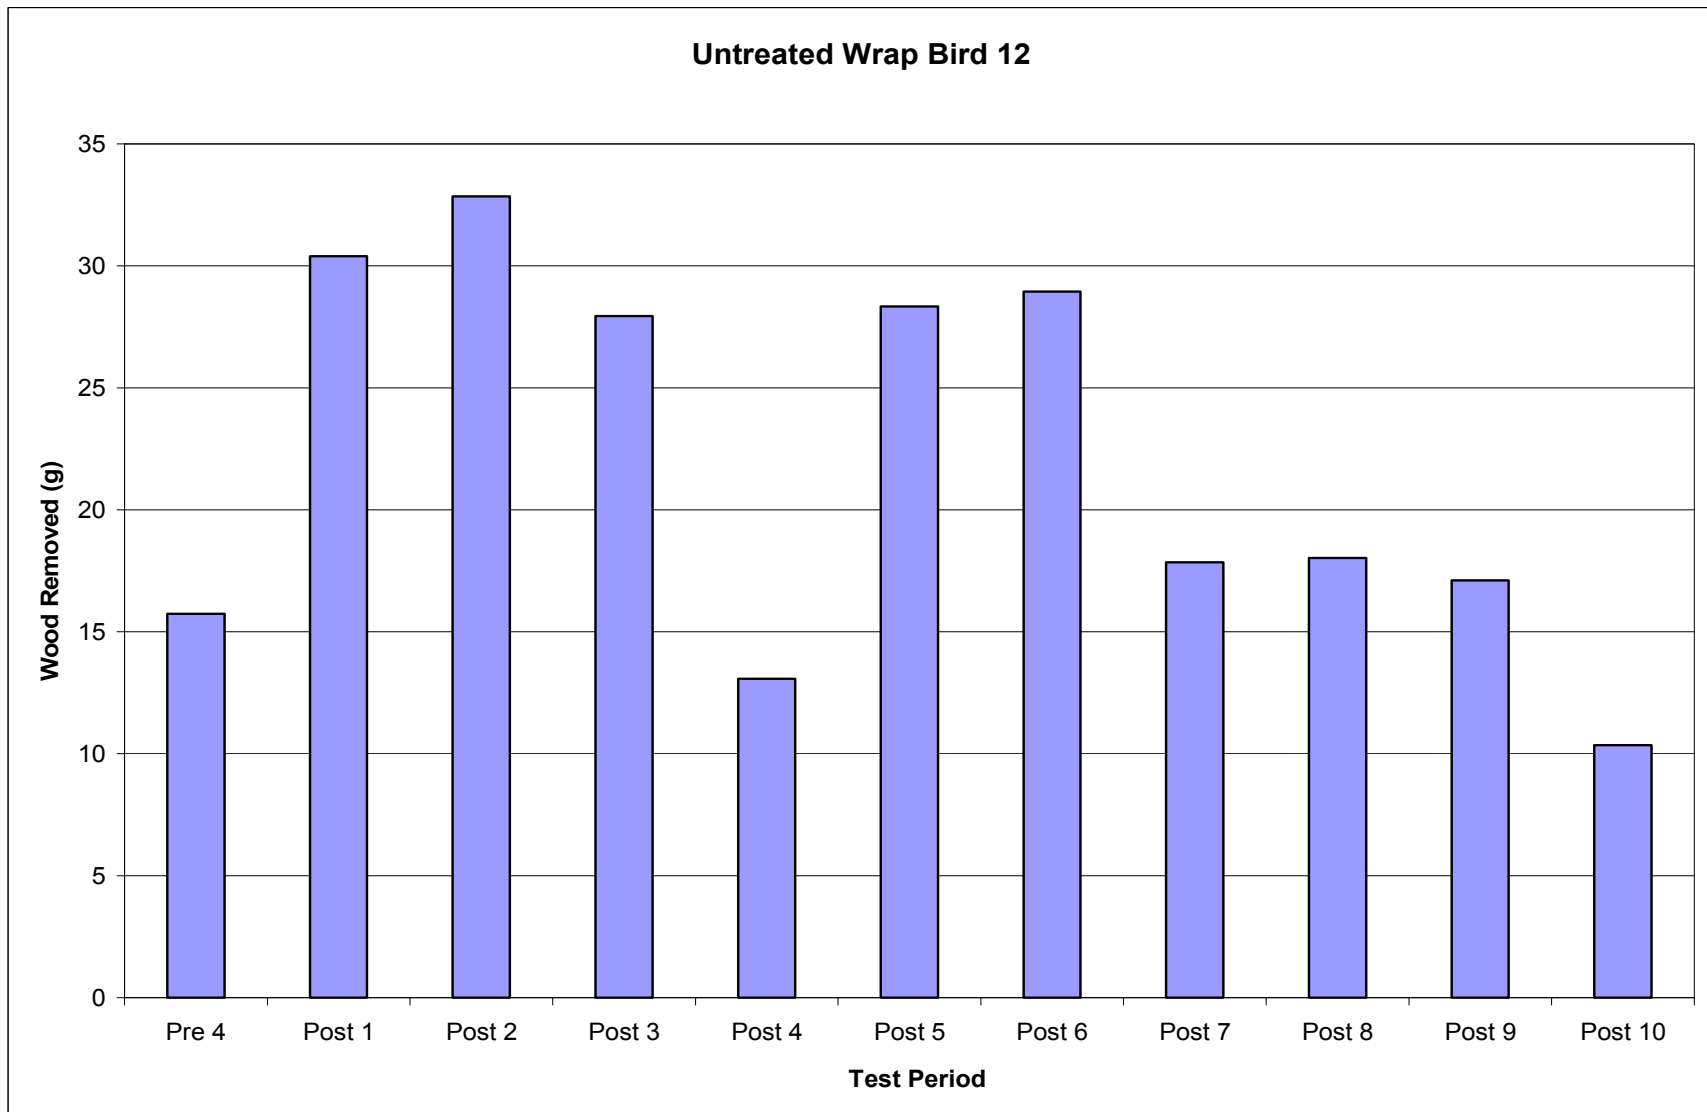
Figure 22: Pileated woodpecker from cage 12, daily damage (g) to the untreated wrap treatment pole. Amount of wood removed by pileated woodpecker in cage 12 from pole section with an untreated wrap.

The amount of wood removed by woodpeckers from poles treated with the PVC wrap decreased from an average of 23.9 grams of wood removed the last day of pre-conditioning period to an average of 11.7 g of wood removed each day during the post-treatment period (Figure 7). This amounted to a 51% reduction in wood removed (Figure 8). Significant variability between the two PVC wraps made it difficult to determine if there was any deterrent effect created by the material (Figure 20). One of the woodpeckers exposed to the PVC wrap removed less post-treatment amounts of wood than any other bird on test (Figure 21). The other bird, which was exposed to the PVC wrap, increased the amount of wood removed during the post-treatment (Figure 22).
